Detection of underwater weak zones of dam seepage, using remote operated vehicle-an emerging underwater technology

The principal aim of the survey was to assessment of underwater weak zones prone of seepage in the upstream face of the Mullaperiyar dam. Identify and locate any incidences of structural damage in the concrete or steel linings using video image recorded in VHS cassettes and compact disk. Delineate the foundation soundness and health of the dam and appurtenant structures.

The Mullaperiyar dam was constructed during 1887 to 1895 across Periyar River in Kerala. The composite dam constructed using lime surkhi and masonry is 1200 ft. long and 155 ft. in height. Lime was used as binding material at the time of construction of the dam. Uncoursed rubble masonry in lime, surkhi and sand mortar was used in upstream and downstream faces whereas lime surkhi using broken stones was used in hearting of the dam. The dam is being owned and operated by Government of Tamil Nadu under lease agreement for 999 years with Government of Kerala. The filling of reservoir was commenced in July 1896. The dam under full reservoir level (FRL) up to 152 ft. irrigates 68558 ha of the Vaigai basin

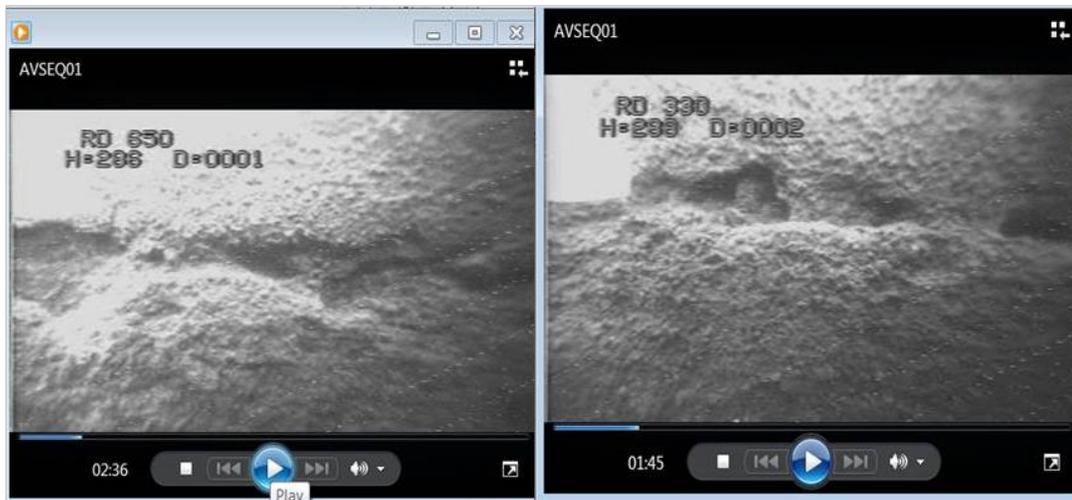
Depth (m) from W.L	Classification of zones	Interpretation from the images
0-3	Zone 1	The plaster seems to be deteriorated. The plaster has been peeled off in some places. Horizontal and/inclined joint with separation exist. Plaster getting crushed at the impact of bumpers and making marks on plaster. Deteriorated plaster zone.
3-5	Zone 2	The mortar is missing in many areas of masonry. Whatever little masonry is remaining is deteriorated. Cavities in greater extent varying in depth are also visible. It seems the plaster has been done but the same is deteriorated. Not getting reflection of light from some cavities. Algae growth seen. Mortar is not flush with rubble. Severely deteriorated zone.
5-7	Zone 3	The mortar is missing in some areas of masonry. Cracked mortar was visible. The mortar is not in flush with rubble. Cavities in lesser extent with smaller in opening size present. Algae growth seen. Deteriorated zone.

Figure-6: Deteriorated plaster zone at 1 and 2 m depth (zone-1).

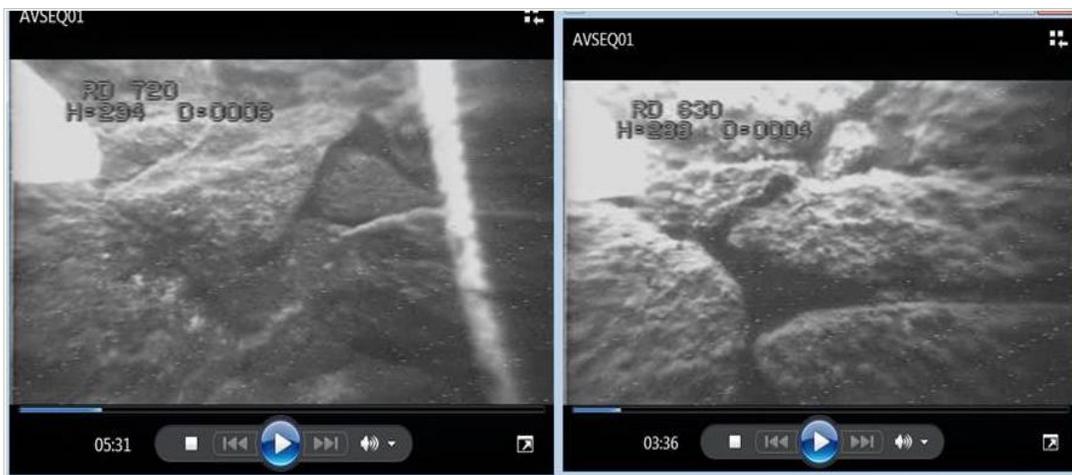
Figure-7: Severely deteriorated zone at 3 and 4 m depth (zone- 2).

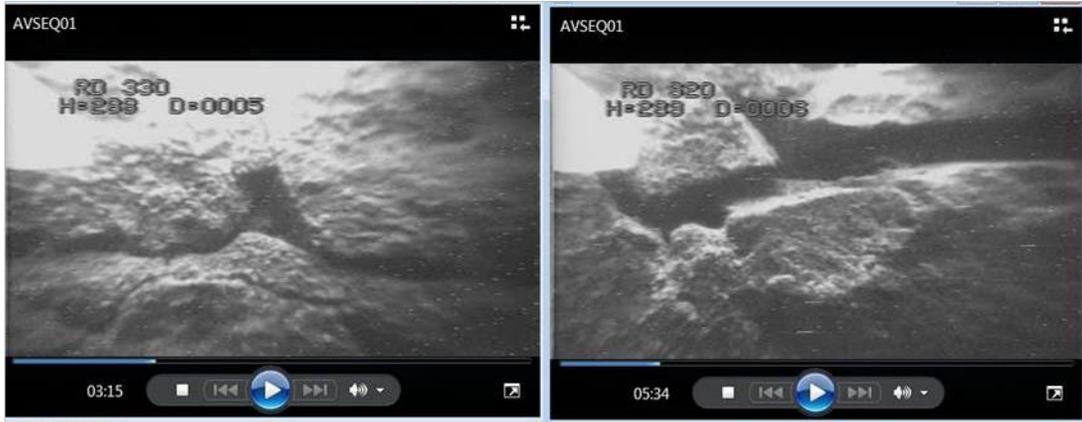
Figure-8: Deteriorated zone at 5 and 6 m depth (zone- 3).

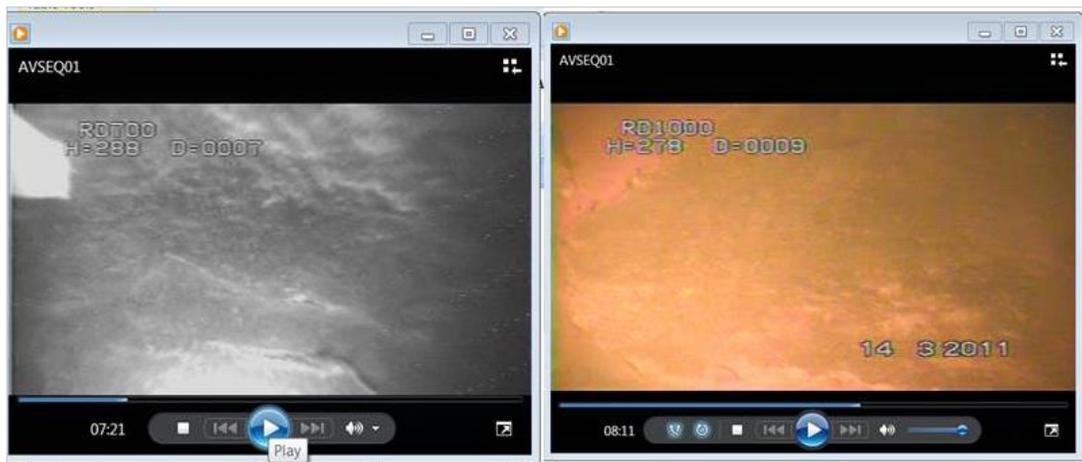
7-9	Zone 4	In the masonry minor cracks were visible in mortar joints. Minor/Moderately disturbed masonry seen. The mortar is in flush with rubble in all places. Generally intact rubble masonry. Intact zone.
Below 9 up to depth scanned	Zone 5	Intact rubble masonry with well healed joints. The mortar is in flush with rubble. No cavities. No missing of mortar. Many black marks were detected but could not be identified. But not problematic. Isolated cracks cavities also present. Even then the masonry is intact.

Figure-9: Intact zone at 7 and 9 m depth (zone- 4).

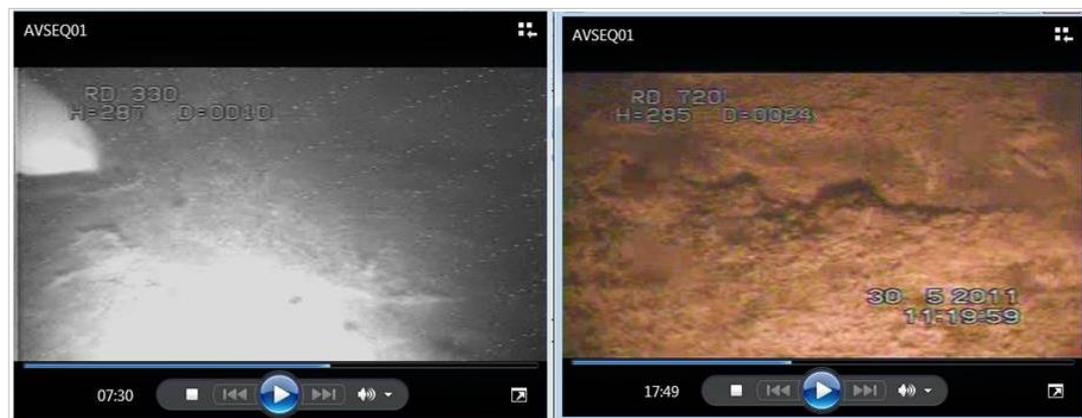
Figure-10: Intact zone at 10 and 24 m depth (zone- 5).
