Review Paper

Environmental Morphodynamics of Rupnarayan River

Gautam Kumar Das

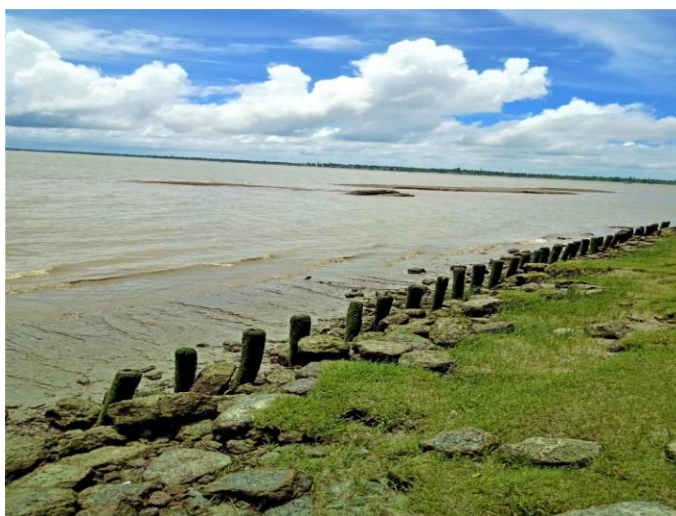
Figure-1: Confluence of Rupnarayan and Hooghly rivers at Geonkhali of Purba Medinipur district (top) and Gadiara of Howrah district (below).

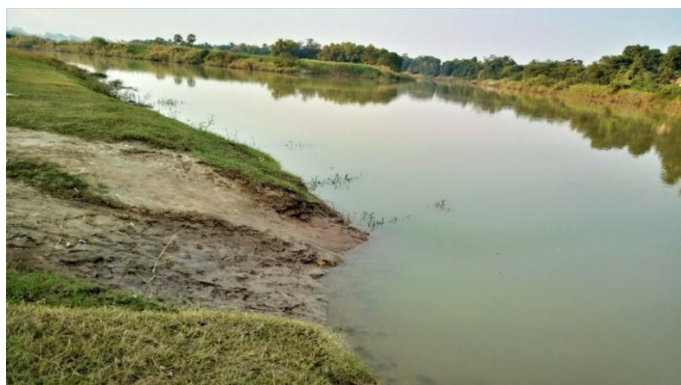
Figure-2: Origin of Rupnarayan River (right) from the union of Dwarakeswar (mid-stream) and Shilabati (left) rivers at Bandar near Ghatal of Paschim Medinipur district.

The Union of Dwarakeswar and Shilabati forms the Rupnarayan River at Bandar near Ghatal town (Figure-2). Rupnarayan is considered as the main river of both Purba Medinipur and Paschim Medinipur districts whereas Dwarakeswar might be considered as the biggest river of Bankura district. Dwarakeswar starts its journey from Purulia district and divides into two halves. This is an important river for Bankura town

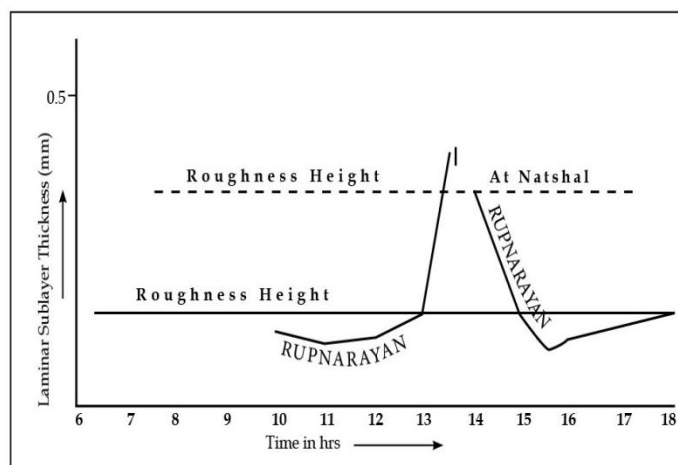
Figure-4: Graphical representation of laminar sublayer thickness against roughness height of Rupnarayan River at Natshal of Purba Medinipur district.

As per the hydrographic observations of the River Research Institute, the rough bed condition is predominant during the ebb tide^{7,8}. The average laminar sublayer thickness higher than the roughness height controls the conditions of no scour formation during the ebb period at Natshal (Figure-4). But the distribution of radial velocity with the angle of deviation of the main flow from the bank line tends to the riverbank of Rupnarayan near Geonkhali, a vulnerable zone of erosion. River Research Institute observed that the radial velocity is different in direction from surface to bottom in downstream stretches of Rupnarayan River^{8,9}. The distribution of radial velocity is positive from surface to mid-depth that leads to the water mass flow towards the bank whereas radial velocity is negative from mid-depth to bottom which attracts water mass away from the bank. Maximum values of radial velocity are near surface and near bottom respectively whereas the value shows zero at mid-depth of the water mass of the river⁷⁻⁹.
