Cause and Effect Assessment after a Complex Failure of a Trunk Piston in Oil Free Compressor

The aim of this research is to develop novel design of high performance piston compressors for the application to railway braking systems excluding oil lubricant. The lifetime and reliability are identified as the most important aspects, which are mainly attributed to the piston surface wear and premature failures in critical applications.

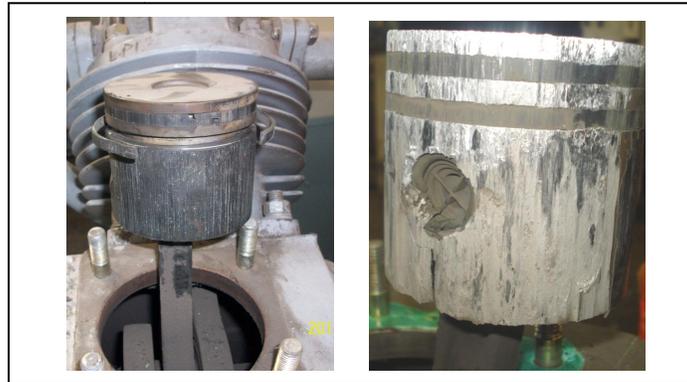
There are two failures happened in the field within a period of four months. The following are failure observations from the field. The duty cycle of the compressor is about 60 % on and 40% off condition and runs for about 8 hours per day with the above duty cycle. The first stage piston found with more scoring marks on the piston skirt and second stage piston is in fully damaged condition as shown in figure 2.

Figure-2
Failed piston

From the above table, it is observed that filtration rating of the filter and rust formation inside the intercooler are the root causes for the more wear and in turn, it leads to damage on the piston and cylinder. The design modified to eliminate the above root causes to avoid the same nature of failure.

The PTFE piston failure is eliminated with by changing interconnecting second stage manifolds from mild steel to copper and copper cooler is replaced with aluminum cooler to avoid rust formation inside the intercooler. The performance test and temperature tests were carried out with modified cooling system and it is meeting the requirement.

Root cause analysis shows that, the filtration rating of the filter and rust formation inside the intercooler are the main cause for the failures. The filtration system improved from 20 microns to 10 microns to prevent the dust particles, which reduces the wear on piston. The cooling system is design is modified to eliminate the rust formation in airflow path to avoid the similar failures in this application. The performances of the modified units are found good after seven months of running.

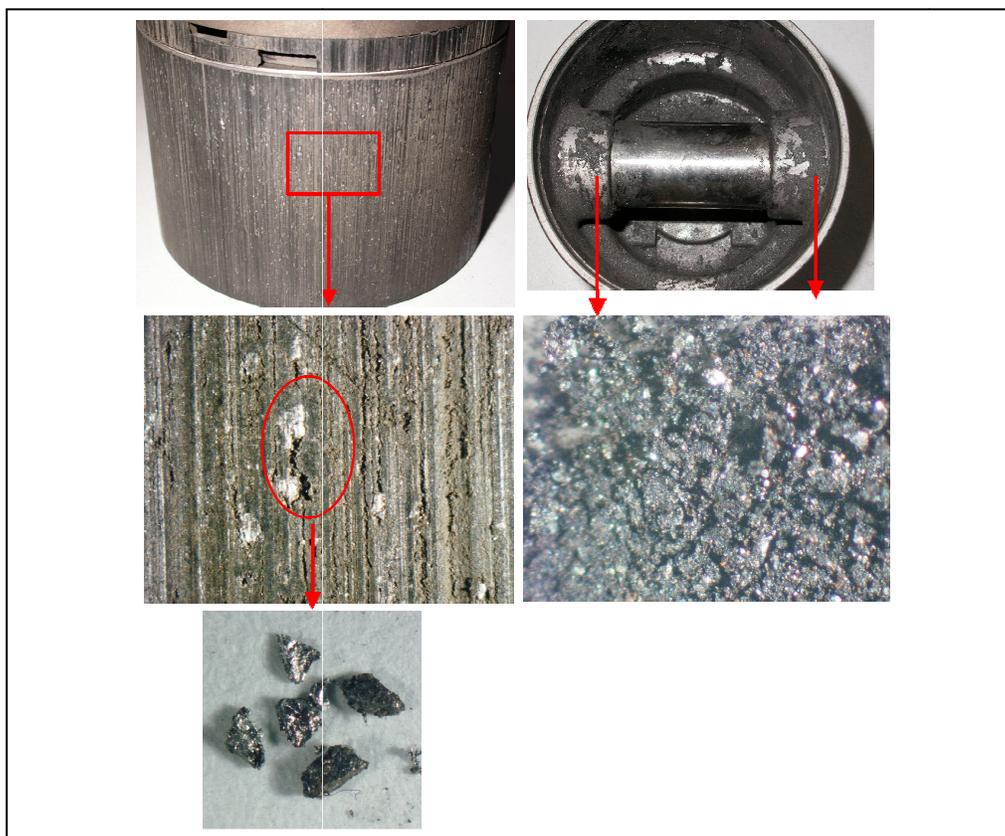
All small end connecting rod bearings and grease inside the gudgeon pin found normal. The connecting rod big end bearings are intact condition while disassembling the compressor. There are more aluminium particles, grease and carbon powder is observed inside the crankcase. Both low-pressure piston and cylinder bore found with scoring marks. Second PTFE ring in the high-pressure side piston totally damaged in one compressor and premature wear on the top rings on both compressors observed. There is no abnormality in all valves and cylinder head. The rust particles are observed inside the header of intercooler, low-pressure delivery manifold and intercoolers drain. The vibration level in the locomotive application is also high, but the compressor is tested with severe vibration test as per the standard. Optical investigation shows more aluminium particles along with PTFE layer in the piston skirt as shown in figure 3.

Figure-3
Optical investigation of failed piston

From the analysis, it is found that the rust formation inside the interconnecting manifolds and Intercooler headers. The cooling system with mild steel manifold and cooper coolers with mild steel headers are well suited for oil-flooded compressors. However, in case of oil free design, during stoppage of the machines, the moisture content in the air is trapped inside the low-pressure delivery manifold and Intercooler leads to rust formation of the internal surfaces the Mild steel headers and manifolds. The rust particles lead to more wear in the second stage PTFE piston. The axial running marks in the piston outside surfaces and rings. The contamination mainly consists of PTFE particles and rust particles.
